Manhole Inspection Summary

Manhole # S51M__017MH

Insp Date: **4/10/08 3:07 PM**

Location Address: **903 Binney St**

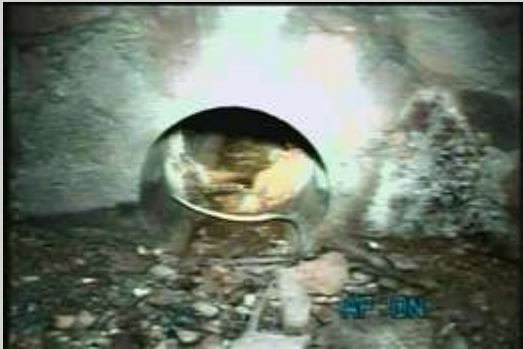
12 O'Clock Outflow

8 in. Circular Gravity Sewer
Pipe Out @ 12 O'Clock

Infiltration: **None** Pipe Seal Cond: **Unknown**
